# ***NEW YORK CITY TRANSIT RIDERS COUNCIL***

## **TROUBLING SIGNS**

**A Signage Survey of the New York City Subway System**

**SEPTEMBER 2002**

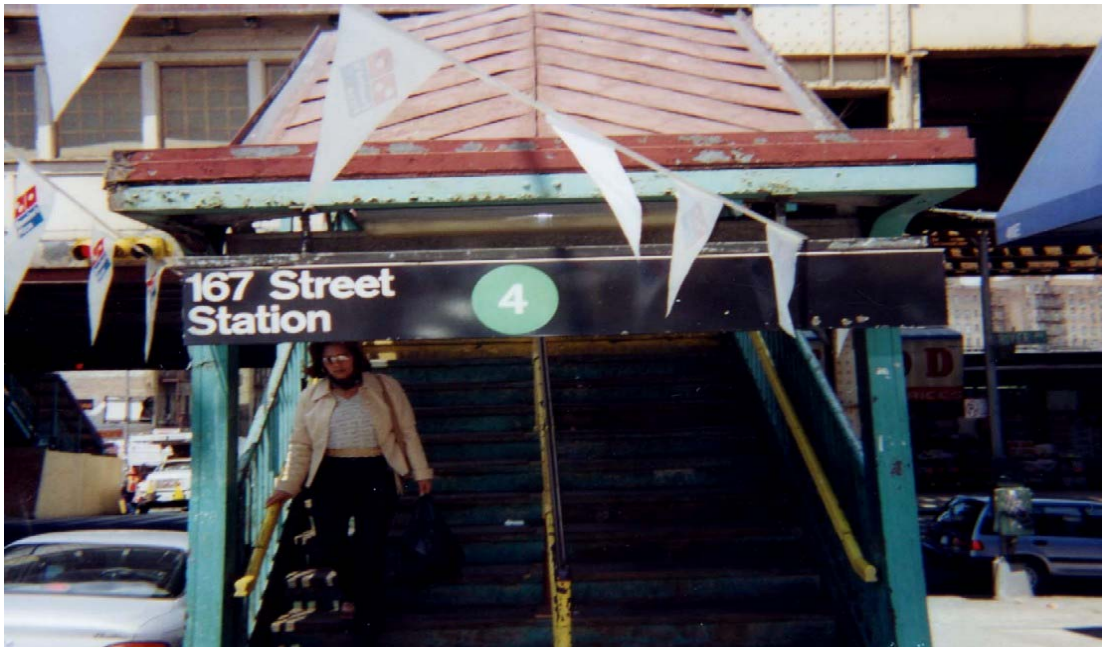
More than half (54%) of the entrances evaluated had at least one signage problem. The most frequent problem was the lack of entrance globes to indicate whether access to the entrance was full-time or restricted during certain hours (22%). Out of the 304 entrances evaluated, 67 entrances were missing globes at 33 stations. Many of these problem entrances are at elevated stations and at entrances located within buildings. These findings are consistent with those found in 1997. A typical example of the missing globe problem was found at the 167<sup>th</sup> Street station on the 4 line.

**167<sup>th</sup> Street station, Bronx (4).** No Globes are present at this elevated station entrance.

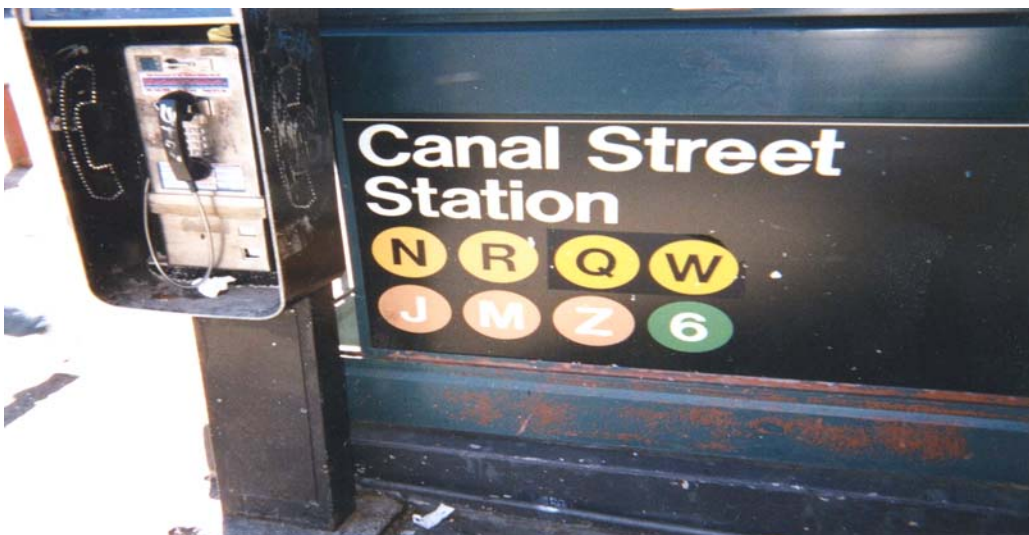
**Canal Street station, Manhattan (N/R/Q/Q Diamond/W/J/M/Z/6).** Entrance sign omits the Q Diamond line.

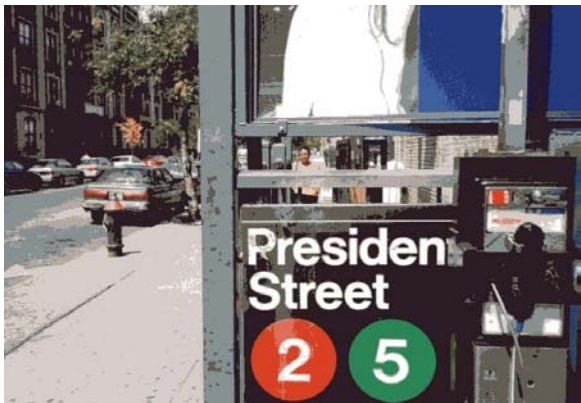
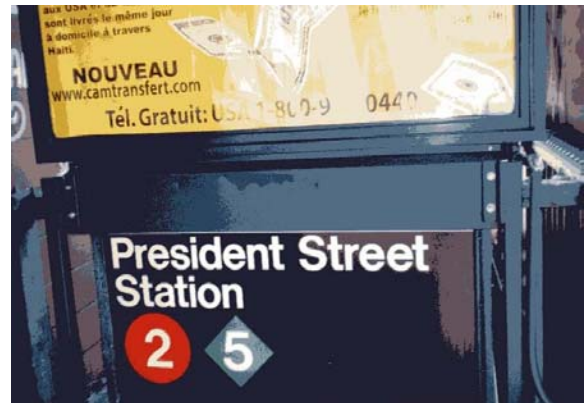
At the President Street station on the 2 and 5 lines, two separate entrances to the station represented the same lines in a different manner.

**President Street station, Brooklyn (2/5).** Two separate entrances list the same 5 line service differently – as a circle and a diamond.

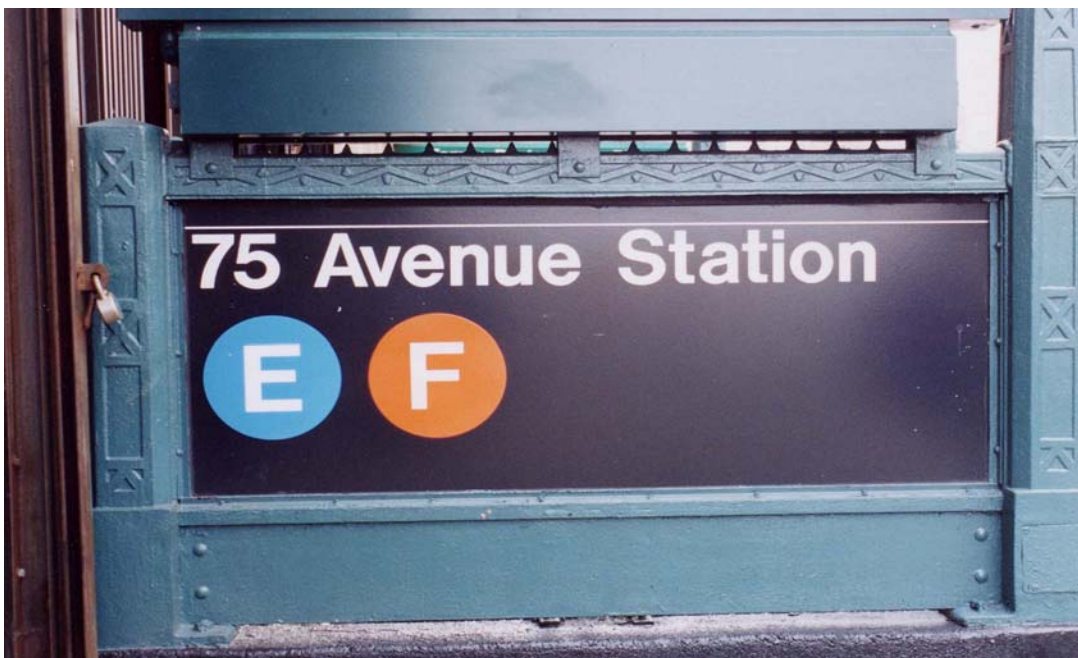
Signage found to be confusing, unclear, and not user-friendly (7%) was often due to giving equal weight to all the lines serving the station, even if they serve the station on a part time basis, or only late nights. This was found at the 75<sup>th</sup> Avenue station in Queens on the E and F lines where the E line is listed on the entrance sign, but only stops at the station after the pm rush. Another example is at the 75<sup>th</sup> Street / Elderts Lane station on the J/Z lines, where the Z line is listed on the entrance sign, but only stops at the station during rush hours.

**75<sup>th</sup> Avenue station, Queens (E/F).** Both lines are given equal weight, but the E only serves the station nights and weekends.

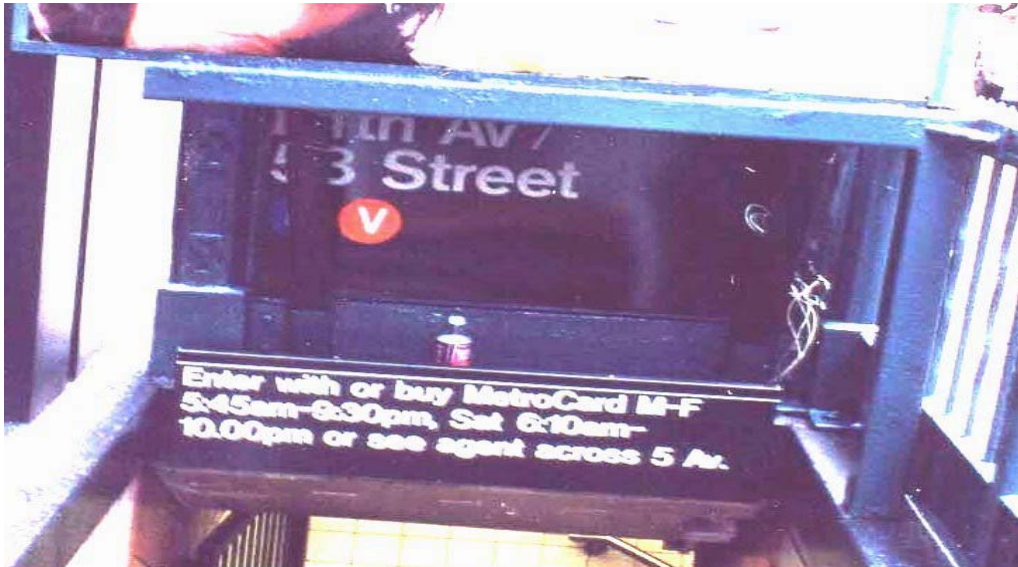
On many entrance signs, the subway line letters or numbers were often partially obstructed from view (8%) by metal advertising structures. Such was the case at the 5<sup>th</sup> Avenue/ 53<sup>rd</sup> Street station.

**5<sup>th</sup> Avenue/ 53<sup>rd</sup> Street station, Manhattan (E/V).** E line is obstructed from view by an advertising bracket.

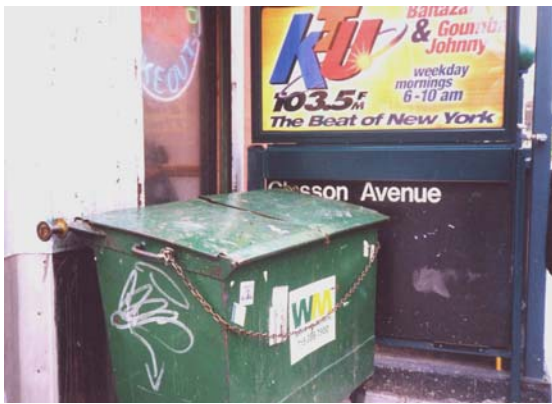
**Classon Avenue station, Brooklyn (G).** Dumpster obstructs listing of lines at entrance.

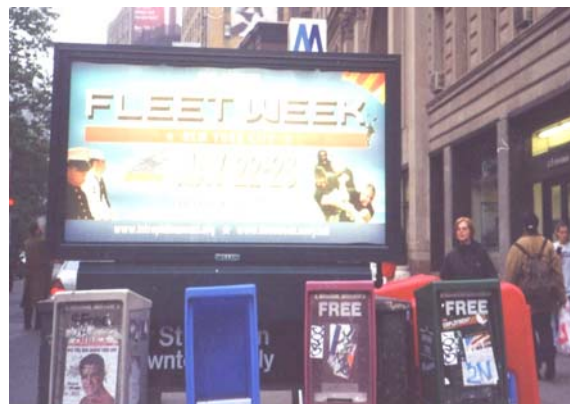
**79<sup>th</sup> Street station, Manhattan (1/2).** Newsboxes obstruct listing of lines at entrance.

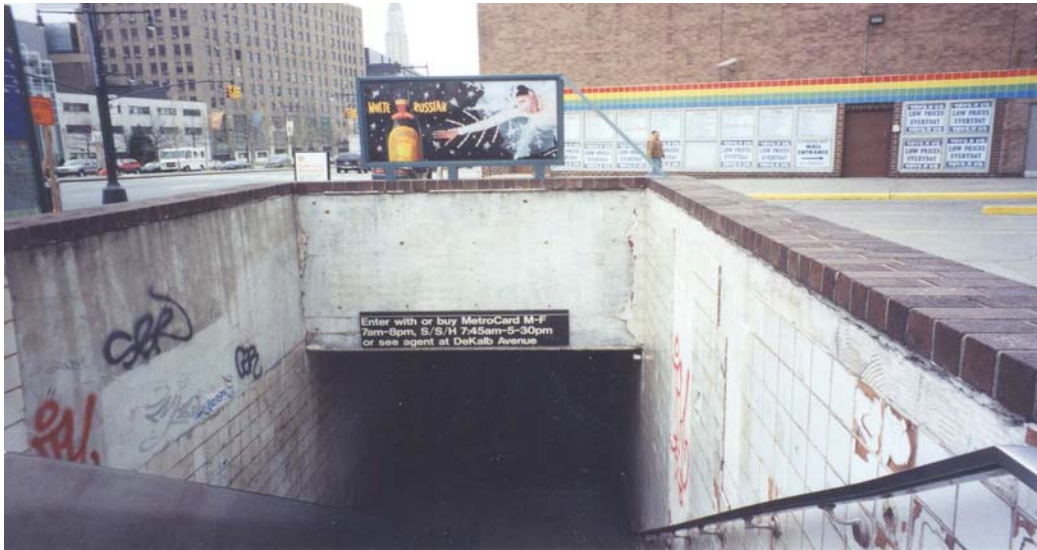
A small number of entrances were missing station name and entrance signs altogether (4%). These entrances appeared neglected, and unsafe, such as the case at the DeKalb Avenue station.

**DeKalb Avenue station, Brooklyn (M/N/R/Q/Q Diamond).** While this part-time entrance provides hour and MetroCard information, it lacks a station name sign with lines serving the station.

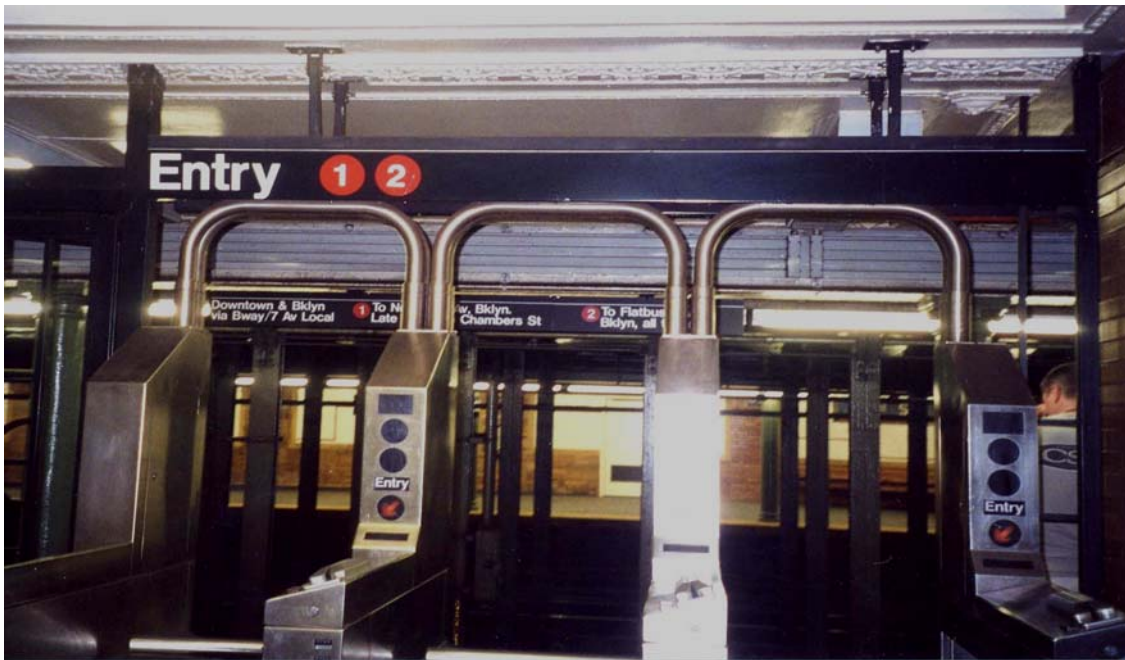
Turnstile signs with inaccurate or inadequate line and service information were also found to be a problem (15%). Many of the turnstile signs omit text identifying the travel direction according to borough. In some cases, more than one borough should have been identified. In other cases, signs failed to indicate a diamond line serving the station.

**66<sup>th</sup> Street/ Lincoln Center station, Manhattan (1/2).** Although the platform edge sign is visible, the turnstile sign does not indicate that entry is for Downtown and Brooklyn only.

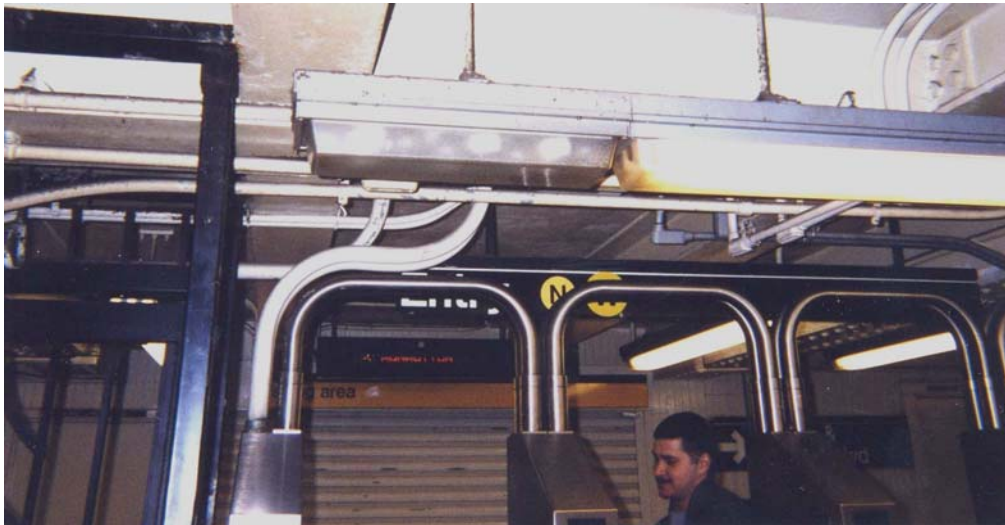
Obstructed turnstile signs were an issue in some of the control areas (7%). Obstructions were often the result of the sign being poorly placed or juxtaposed to other control area informational signs.

**36<sup>th</sup> Avenue station, Queens (N/W).** The turnstile sign is blocked by the High Entrance Exit Turnstile, light fixtures, and pipes.

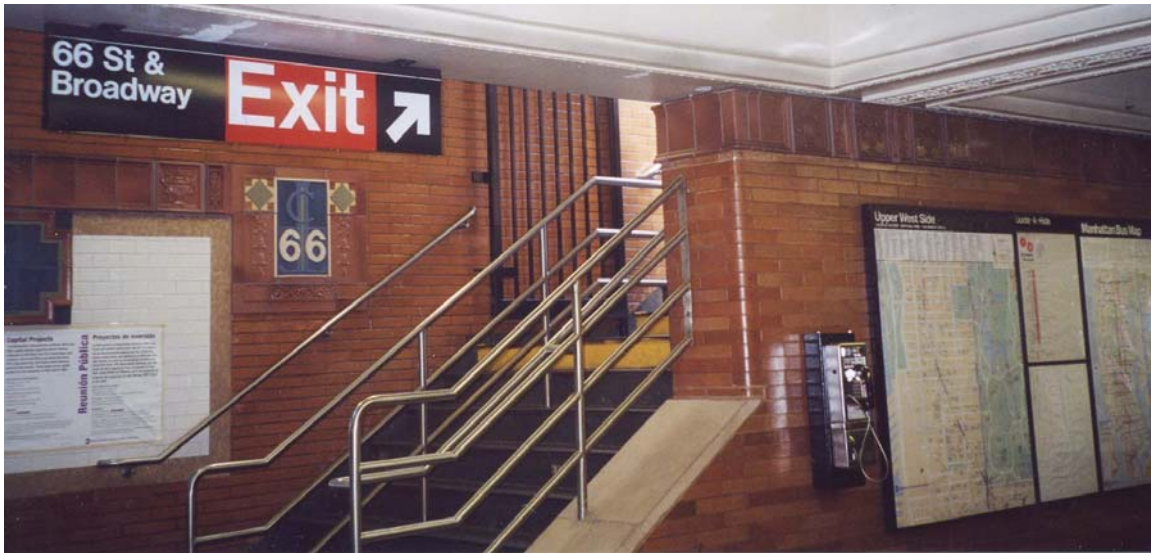
**66<sup>th</sup> Street/ Lincoln Center station, Manhattan (1/2).** Exit sign omits street corner direction.

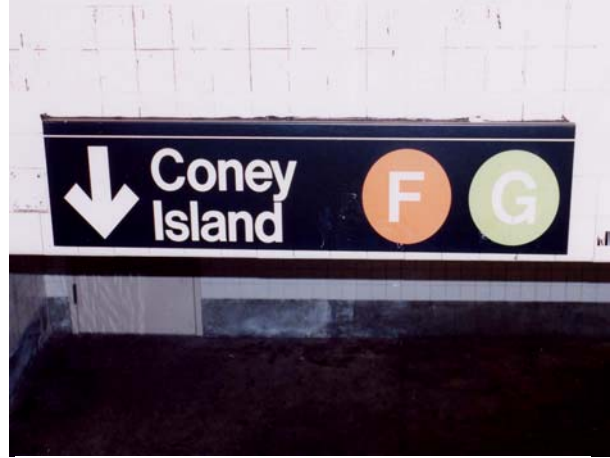
**Carroll Street station, Brooklyn (F/G).** Inaccurate travel information - the G line does not go to Coney Island.

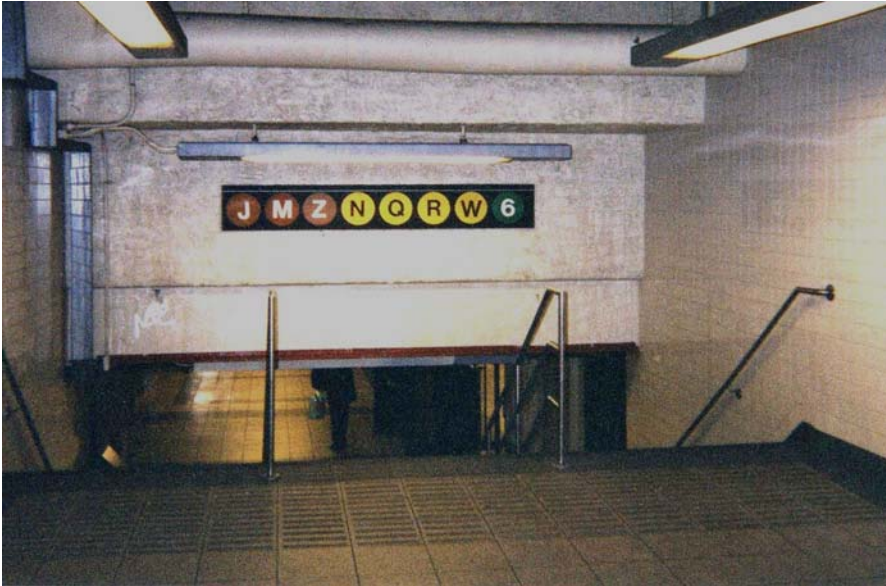
**Canal Street station, Manhattan (J/M/Z/N/Q/Q Diamond/R/W/6).** Transfer sign does not list Q Diamond line.

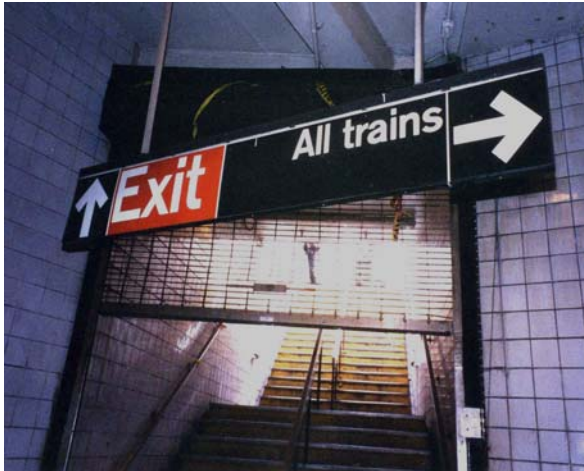
**DeKalb Avenue station, Brooklyn (M/N/Q/R).** Mezzanine sign does not indicate direction of travel or line information

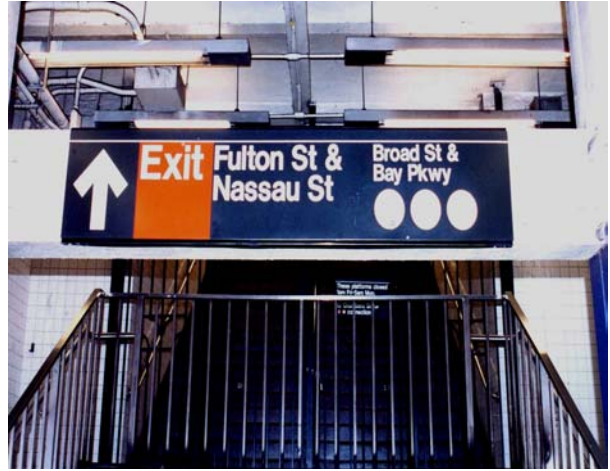
**Fulton/ Broadway Nassau Street station, Manhattan (A/C/J/M/Z/1/2/4/5).** Exit/ Transfer sign does not list open hours at stair or prior to stair.

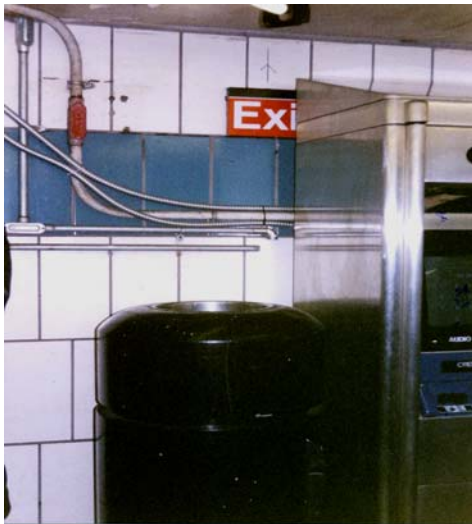
**Fulton/ Broadway Nassau Street station, Manhattan (A/C/J/M/Z/1/2/4/5).** TVM machine is blocking an exit sign.

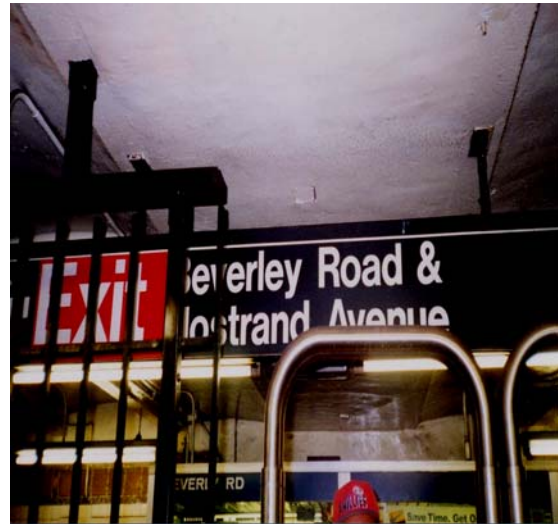
**Beverly Road station, Brooklyn (2/5).** Not only is the exit sign obstructed by the High Entrance Exit Turnstile, but Beverly Road is spelled incorrectly.

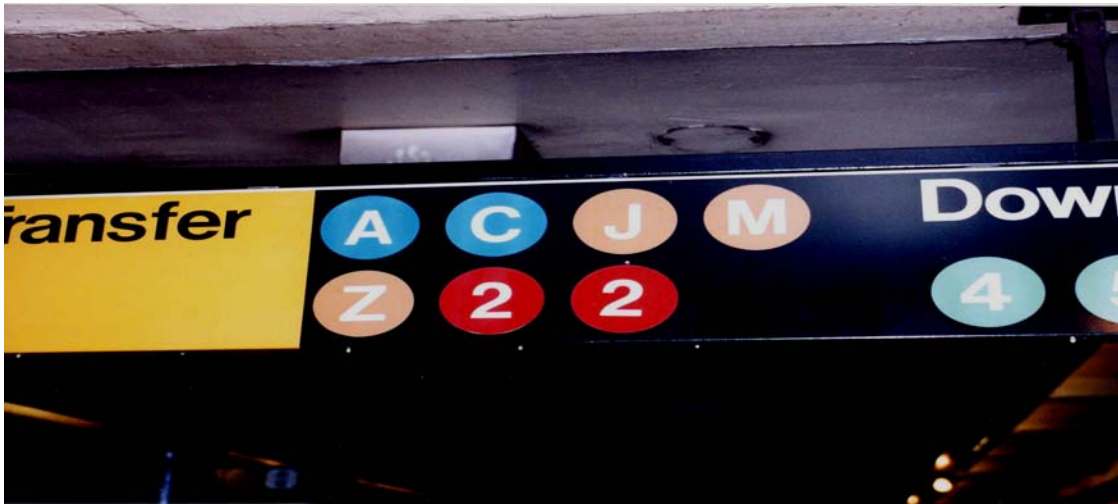
Some problems were found with platform directional signs with transfer information (5%). In some cases signs provided incorrect information, while in other cases, signs were damaged.

**Fulton Street/ Broadway Nassau Street station, Manhattan (A/C/J/M/Z/1/2/4/5).** The 2 line is listed twice on this sign. The 1 line, which should be listed here, is omitted.

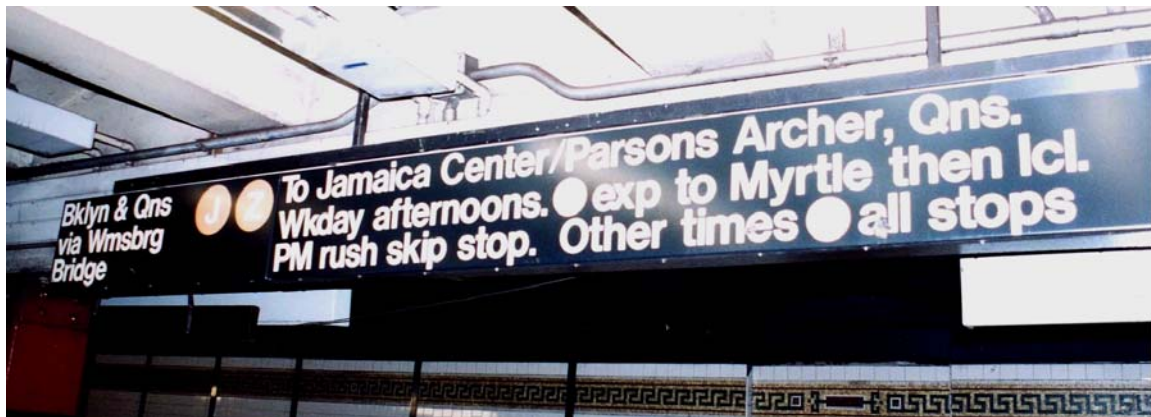
Another key problem identified with platform edge signage was that the information was unclear or confusing to riders (25%). One key reason for this is the lack of an hourly definition given to the terms: rush hours, middays, evenings, weekends, and late nights. As was noted in detail in the 1997 study, exact hours of service can be critical for riders.<sup>17</sup> There is also a general lack of information provided about skip stop service. Riders unfamiliar with the system do not know that certain lines are skip stop service only.

**Fulton Street/ Broadway Nassau Street station, Manhattan (A/C/J/M/Z/1/2/4/5).** Lack of hourly definition given to weekday afternoons and pm rush makes service information confusing.

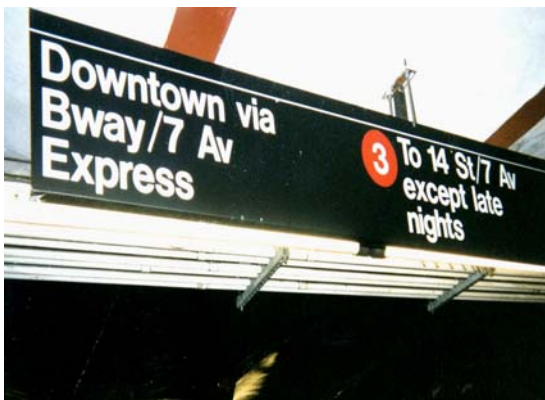
**72nd Street station, Manhattan (1/2/3).** No alternate line is listed for riders to use when the 3 line is not running.

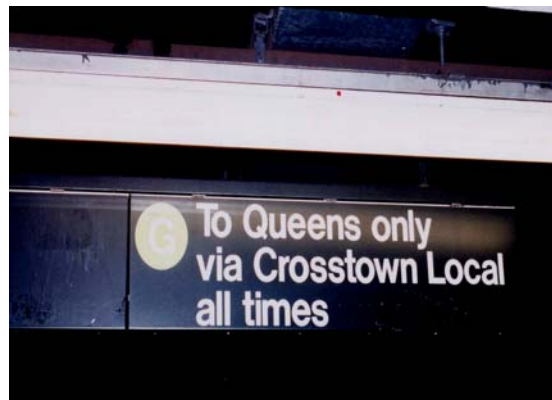
**Carroll Street station, Brooklyn (F/G).** Misleading travel information. This sign omits Brooklyn as a direction.

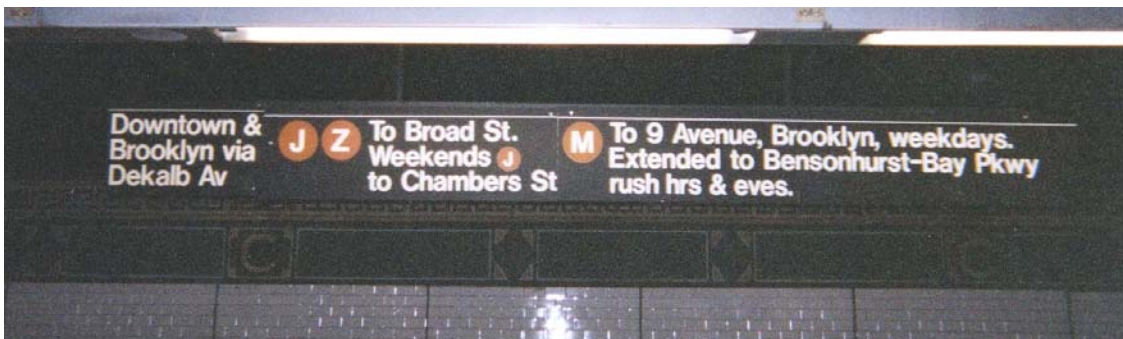
**Canal Street station, Manhattan (J/M/Z/N/Q/Q Diamond/R/W/6).** No alternate line information is provided for service to 9<sup>th</sup> Ave. or Bay Parkway on weekends.

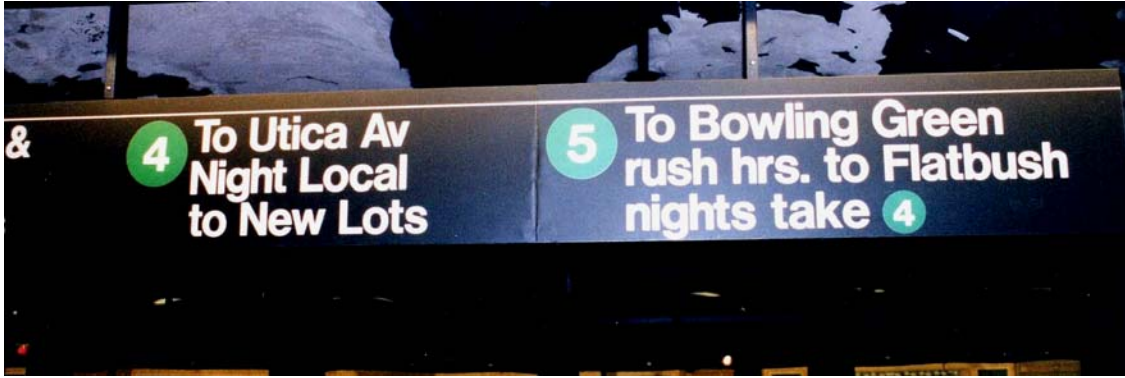
**Fulton Street/ Broadway Nassau Street station, Manhattan (A/C/J/M/Z/1/2/4/5).** Incorrect end destination information. The 4 Line does not run to New Lots Avenue.

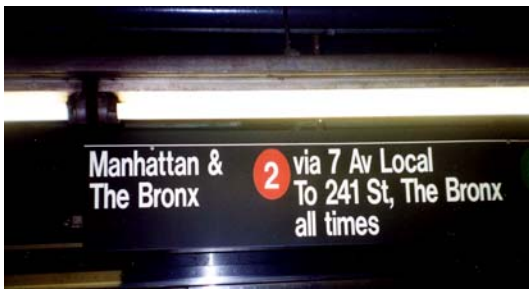
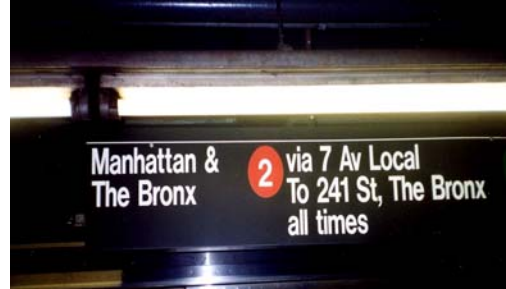
**President Street station, Brooklyn (left); Beverly Road station (right) on the 2/5 lines.** Inconsistent end destination information. Same line, inconsistent platform edge signs at two different stations.

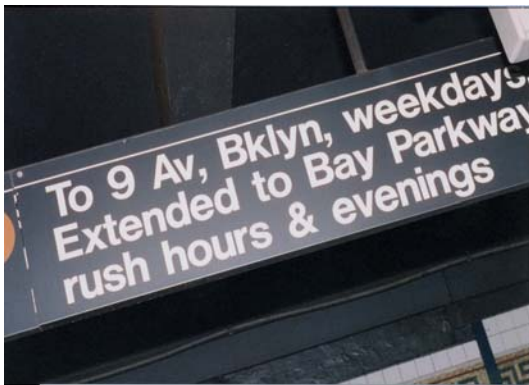
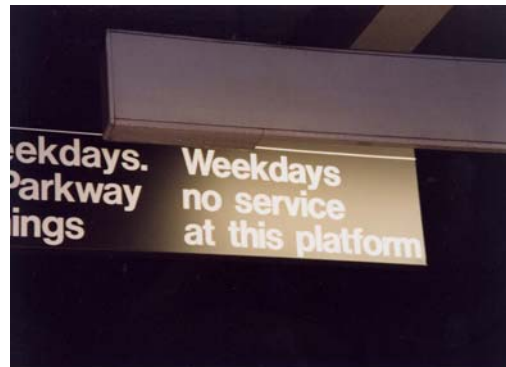
**Fulton/ Broadway Nassau Street station, Manhattan (A/C/J/M/Z/1/2/4/5).** Description indicates that service runs on weekdays (left), but attached description on same sign (right) states that there is no weekday service. Sign should state "weekends no service at this platform."
